A Search for the Misplaced IUD

DOI 10.5001/omj.2023.122

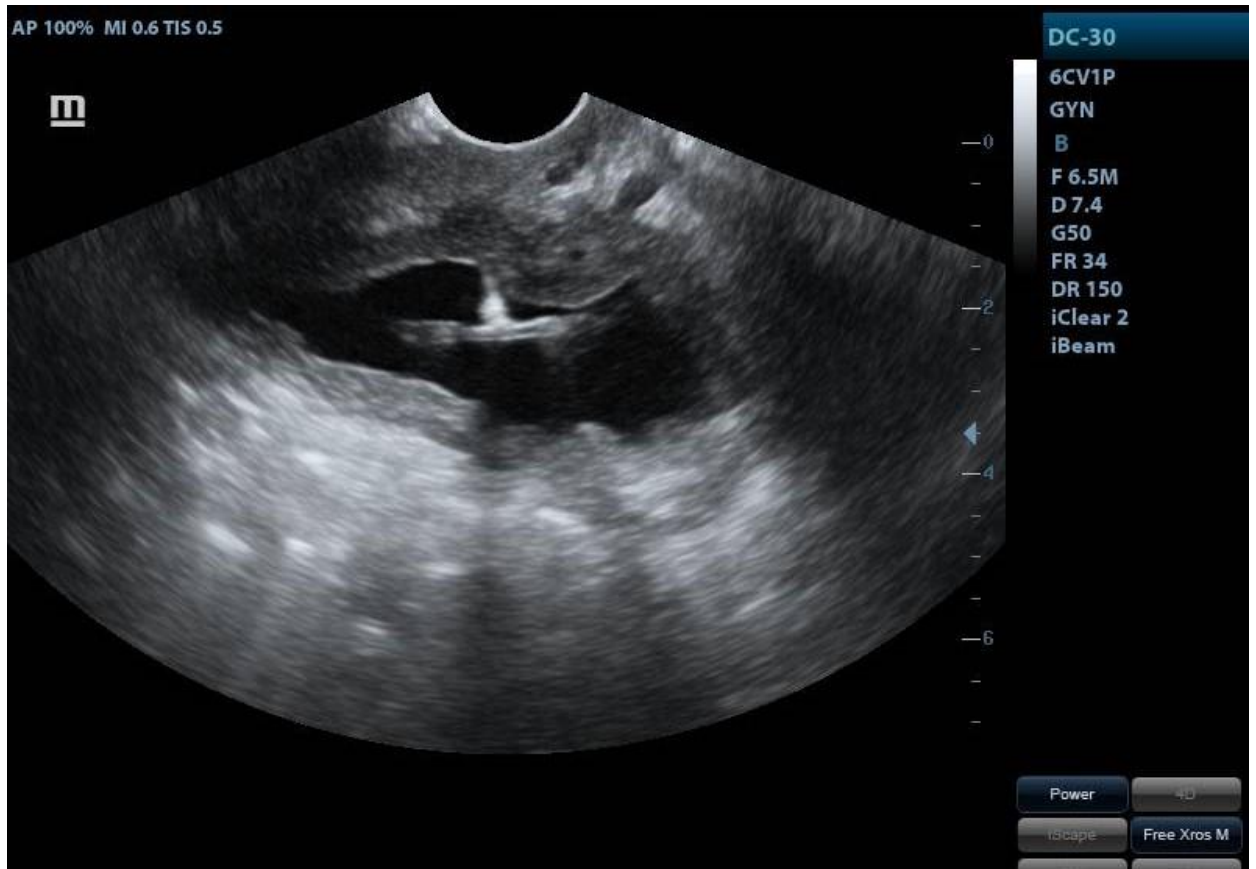
Figure 1: Ultrasound scan revealing the location of the copper-T located in the cavity of the organ anterior to the uterus.

On transvaginal ultrasonography, the copper-T was not seen in the uterine cavity, and the patient did not report a history of spontaneous expulsion. The diagnosis of misplaced IUD was made, as the uterine cavity was empty. A whole abdominal scan and pelvic scan with a full urinary bladder were conducted to locate the copper-T [Figure 1].

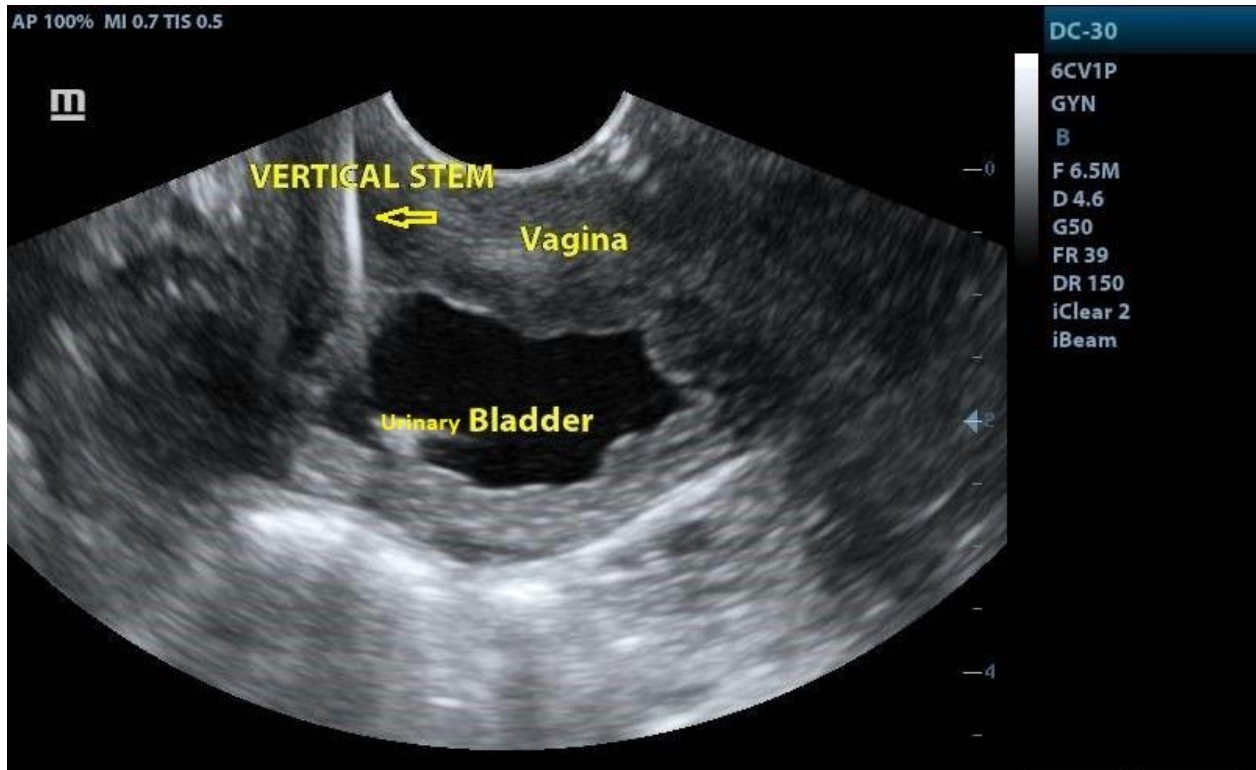
Figure 2: The vertical limb of copper-T is seen inside the urethra and horizontal limbs at the urinary bladder neck.

The patient has complaints of micturition, with no difference in symptoms upon postural changes. This has raised suspicions of the migration of the copper-T to the bladder. We directed our search for the misplaced copper-T to the urinary bladder. A transvaginal scan was performed with the bladder full, and to our surprise, the Copper-T was located in the urinary bladder. Upon detailed examination, the vertical stem of the copper-T was found in the urethra [Figure 2], and a thread-like structure was visualized extending from the urethra [Figure 3]. The copper-t thread was grasped with artery forceps, and under the guidance of ultrasonography, the copper-T was gently and cautiously extracted to prevent injury to the urethra [Figure 3].

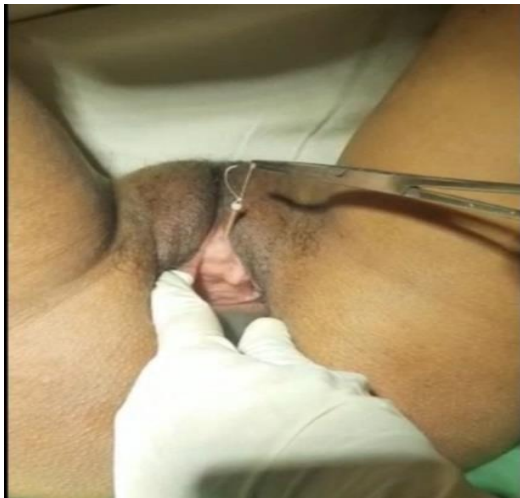
Figure 3: Retrieval of the copper-T.

The removal of misplaced copper-T can be a challenging task. In our case, since the thread was protruding through the urethral meatus, retrieval was relatively straightforward. However, cystoscopy is often necessary for extracting the copper-T from the bladder. Additionally, instances of vesical stone formation around the Copper-T have been reported in the literature, which can complicate matters to the extent that surgical procedures like suprapubic cystolithotomy are needed for removal.³ This can also result in the formation of vesicovaginal fistulas and vaginal calculi.⁴
